Failure Mode Testing During Verification Identifies Mechanical Failure in an ABSL-3 Facility

Amy Helgerson, MS, RBP
Environmental Health and Safety
Iowa State University

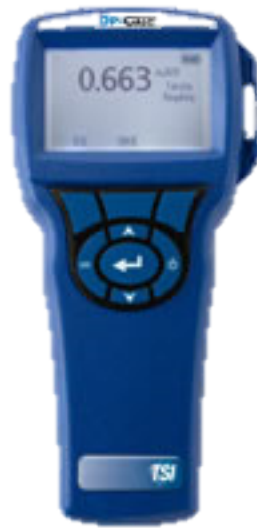
Micromanometers

- Differential pressure between spaces
- Placed in doorways between adjoining spaces
- Failure mode testing mirrored previous year

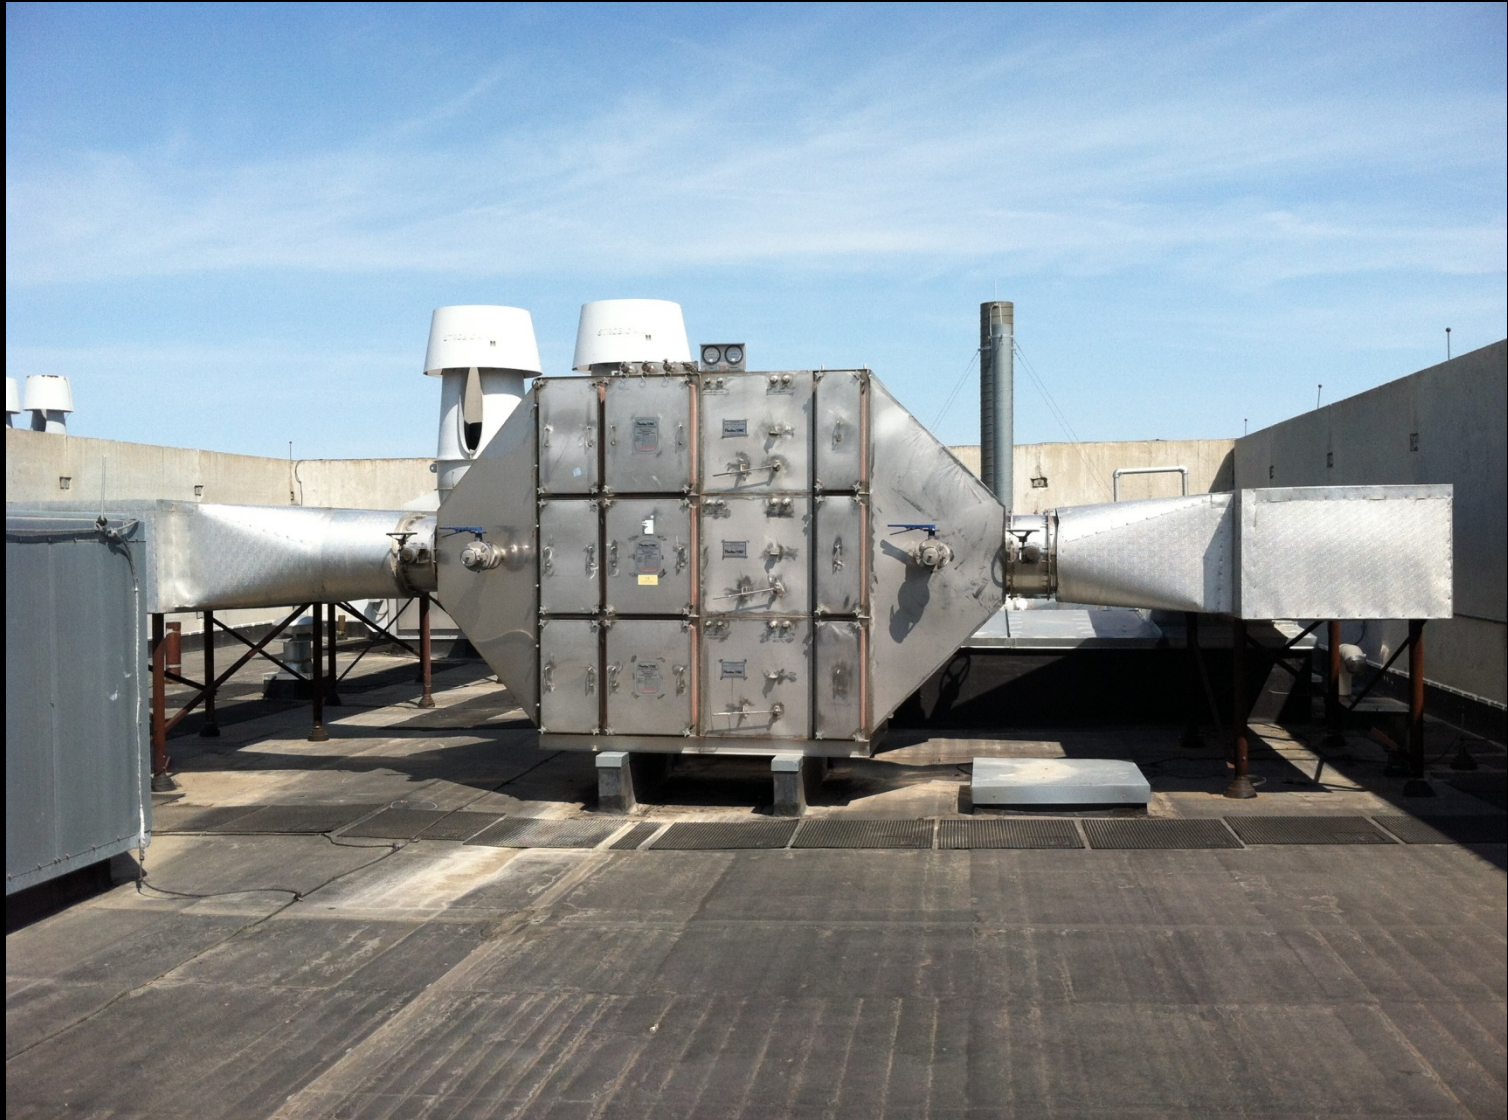
HVAC system

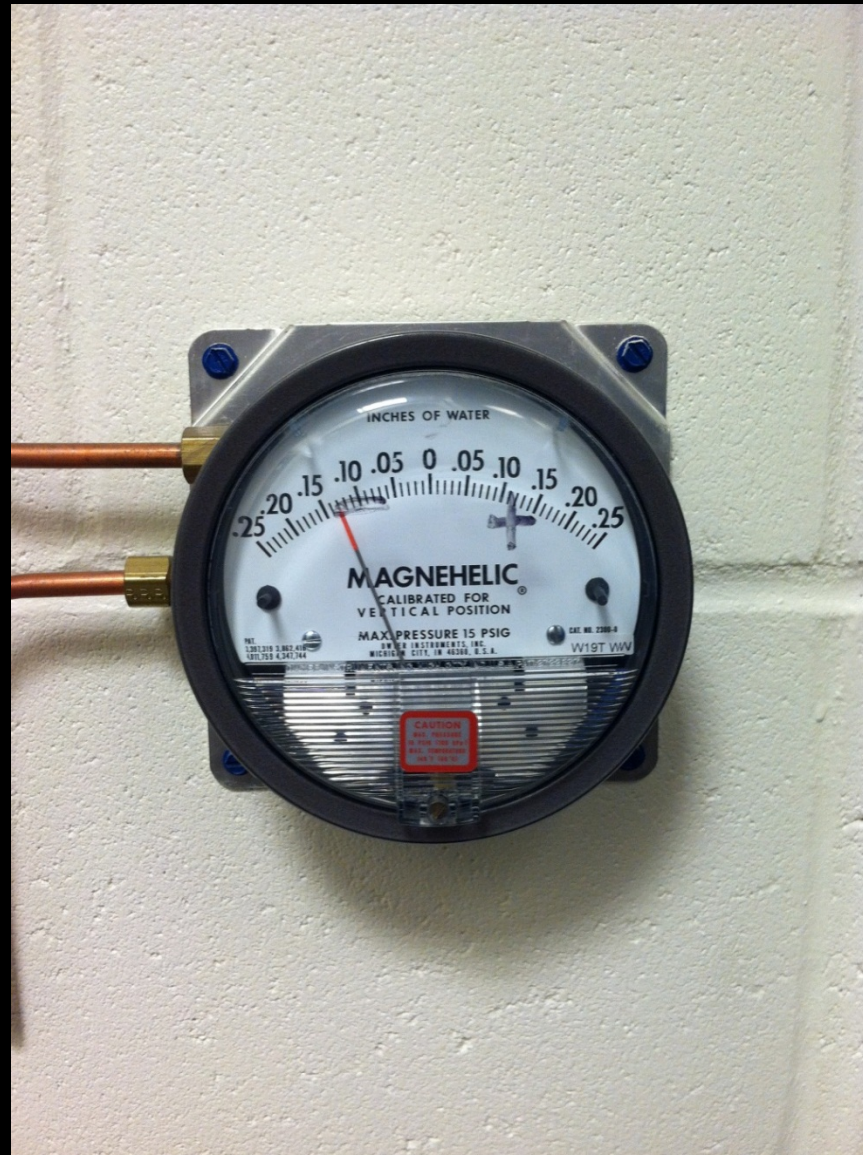
Magnehelic gauges

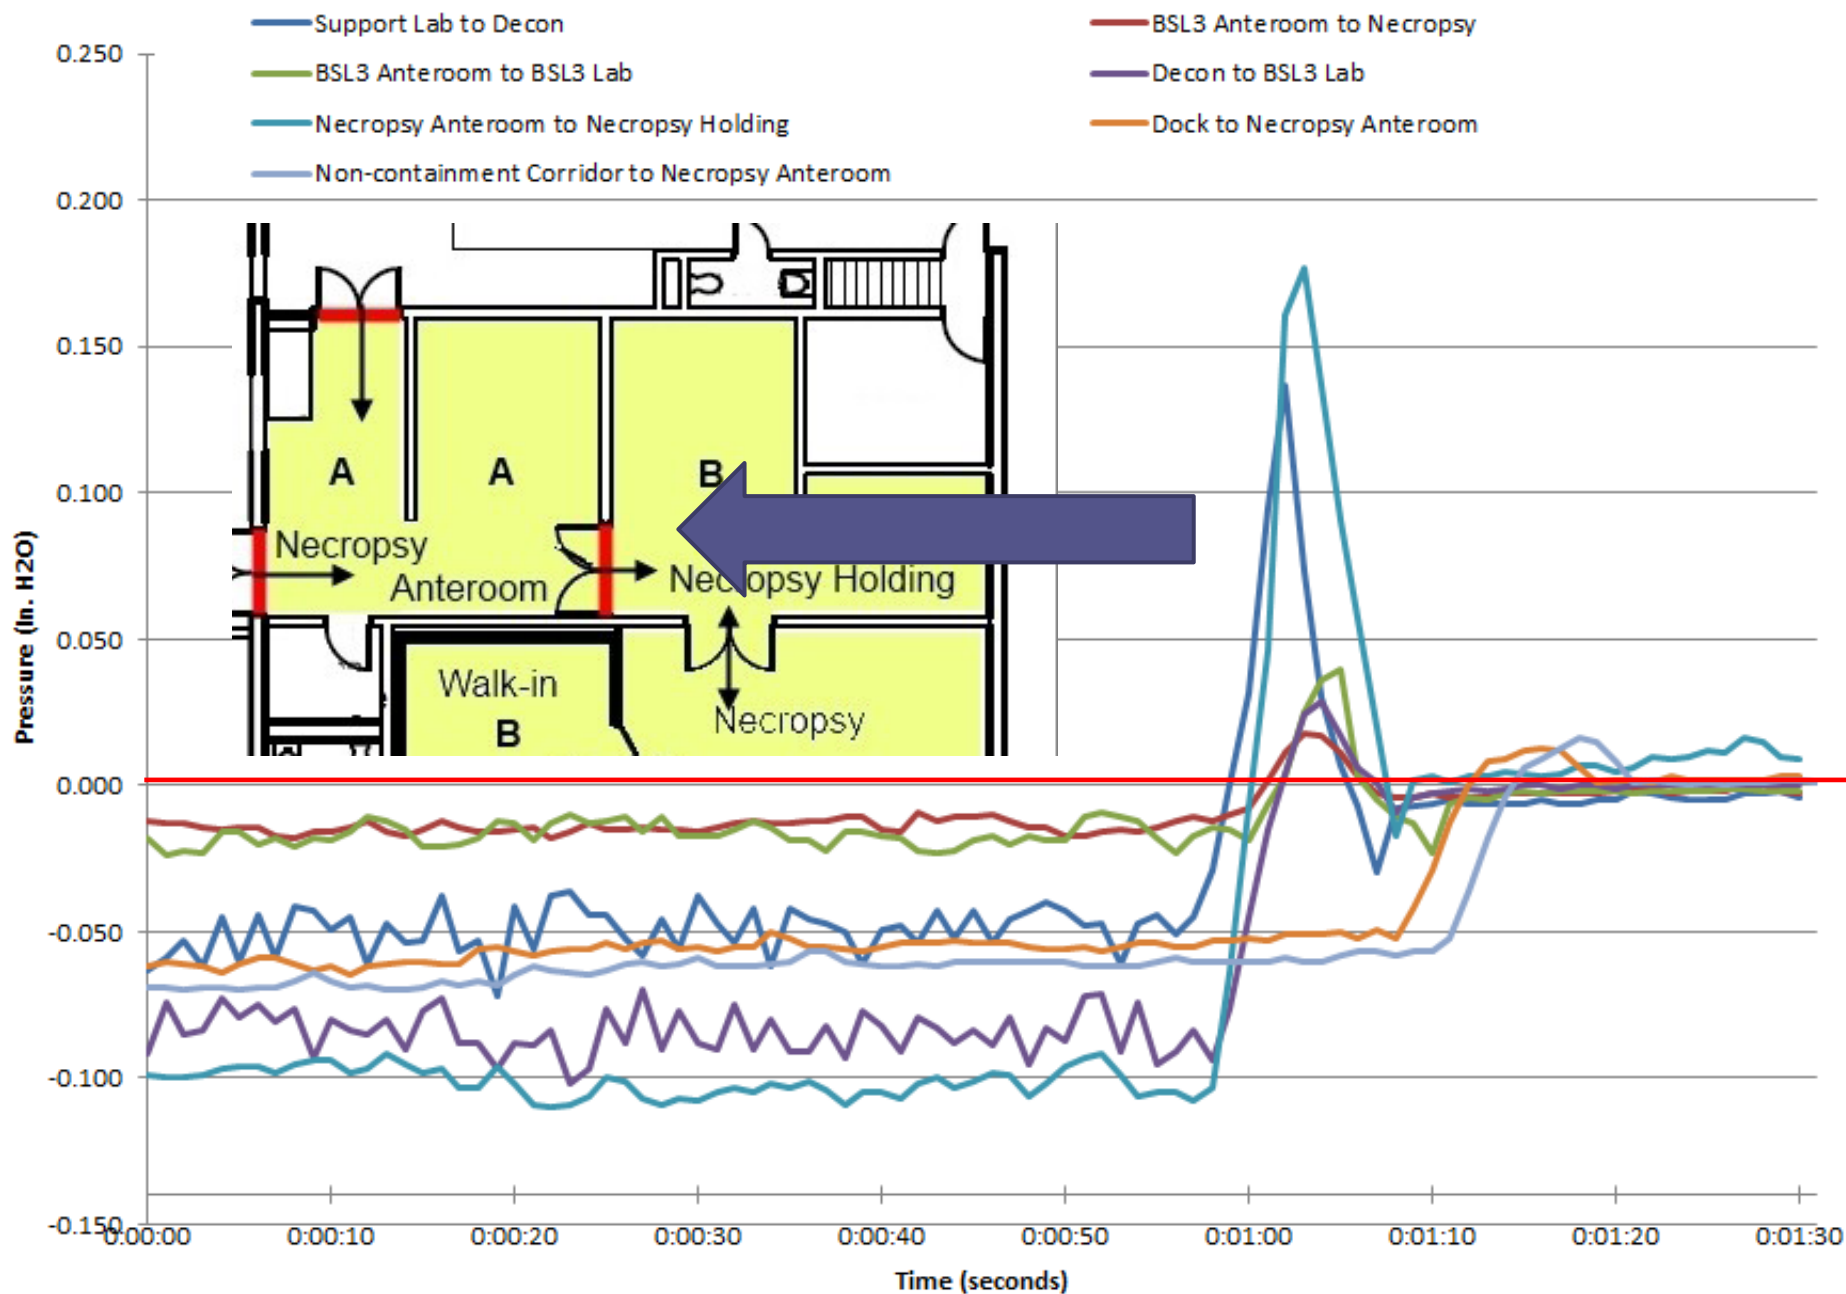
Fail Both Exhaust Fans

Potential culprits

- Improper air valve settings
- Unsynchronized supply and exhaust
- Dry plumbing traps

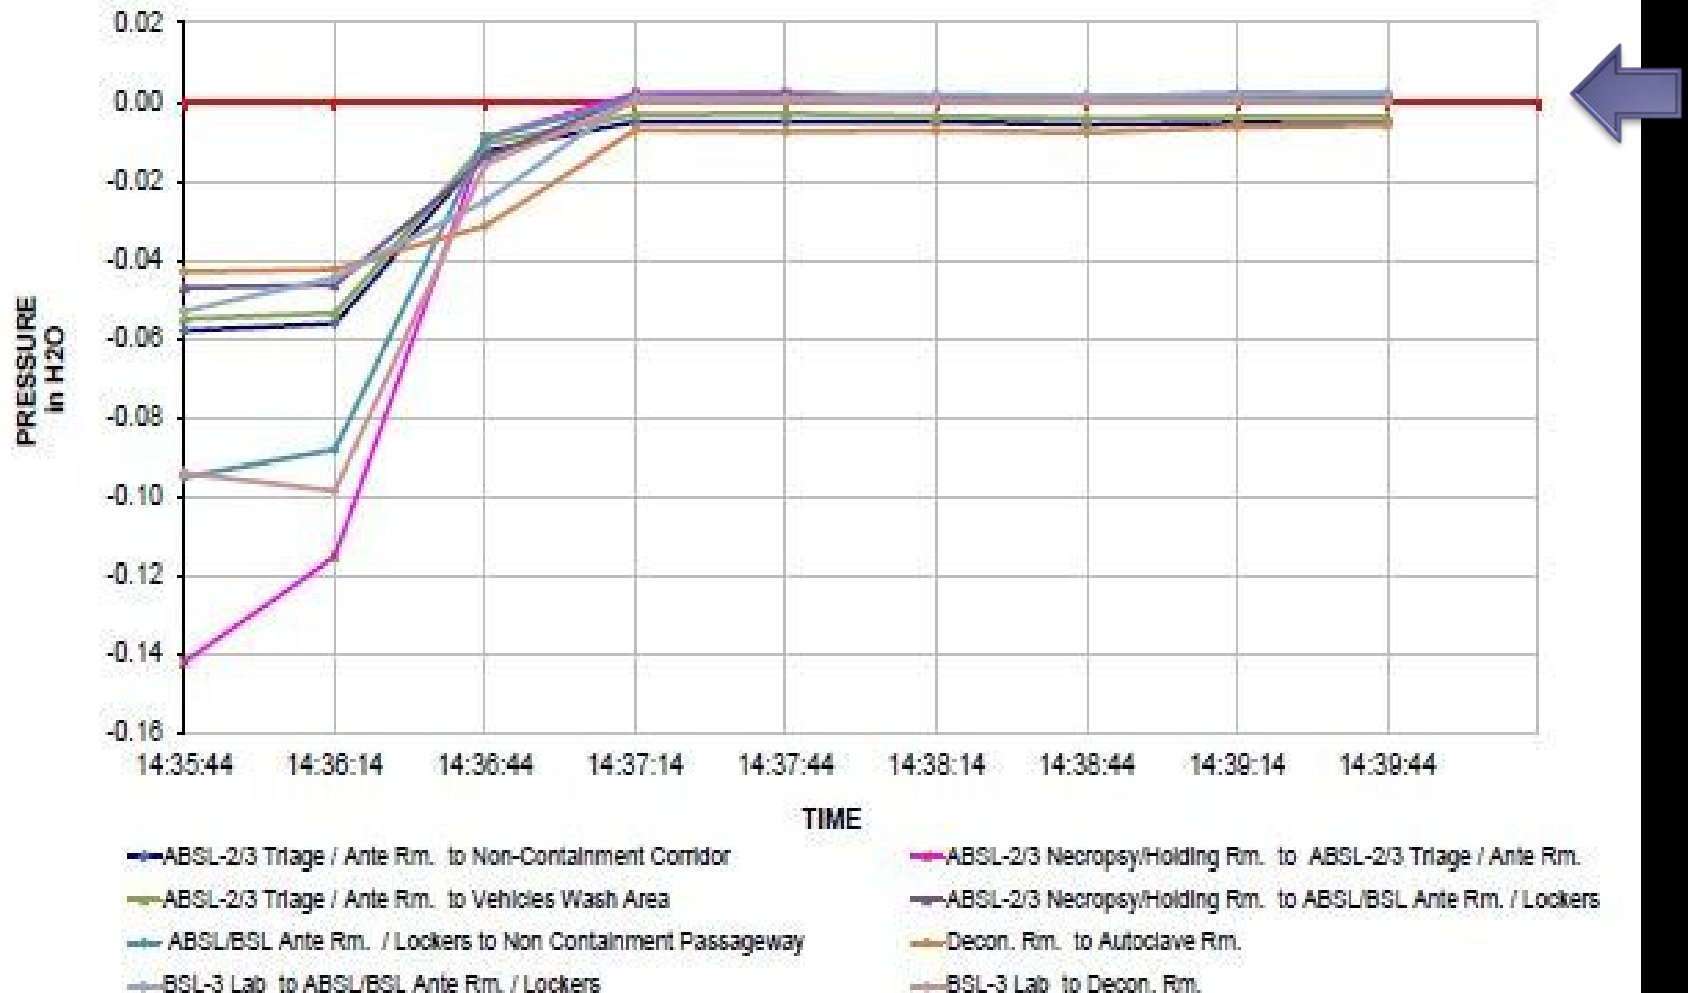
Next time....

Fail EF-11A & EF-11B
